SEAWALL AND REVETMENT EFFECTIVENESS, COST AND CONSTRUCTION

by COURTLAND A. COLLIER

REPORT NUMBER 6

MAY 1975

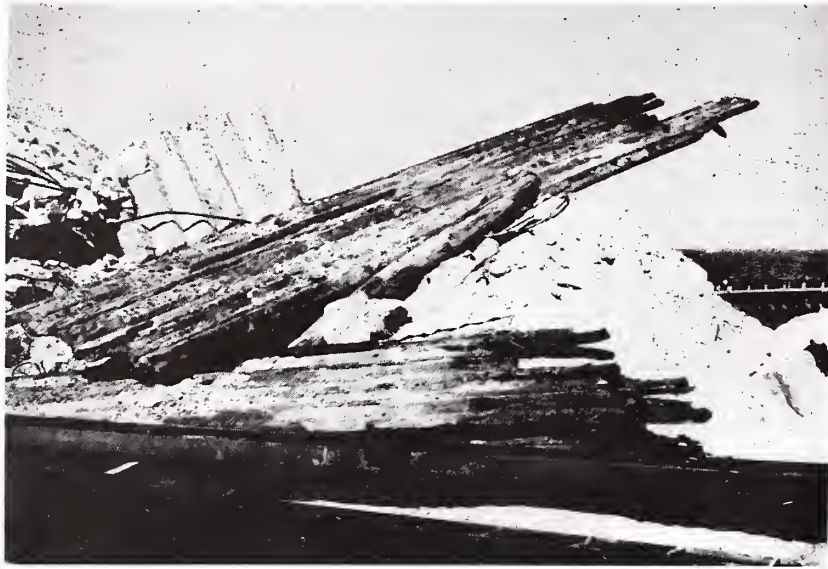
For example, Figure 1 shows steel sheet piling extracted after about 12 years of service at Boynton Inlet near Palm Beach. Close inspection reveals that portions embedded in the sea bottom show some loss, while the areas exposed to the spray zone have severely deteriorated. The sheet piles carry the remains of a bitumen coating applied at the time of installation.

Fig. 1. Steel sheet pile corrosion after 12 years service

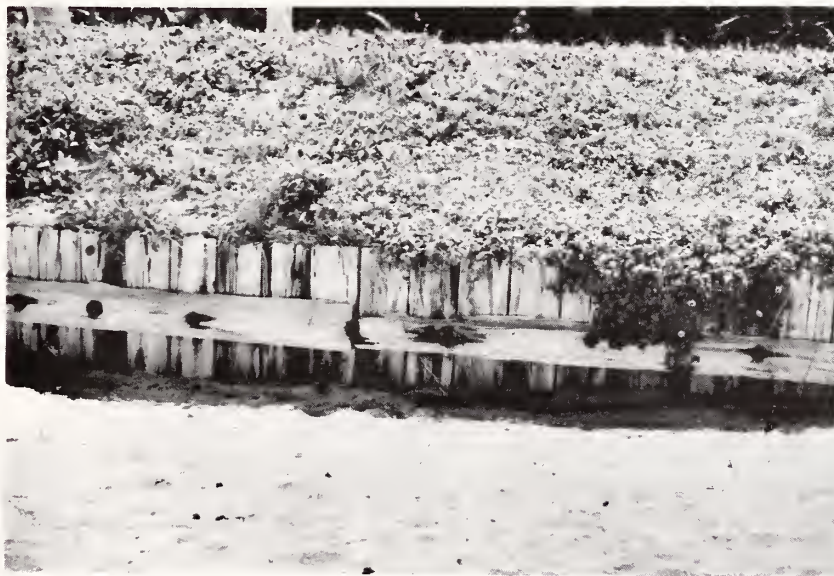
Fig. 2. A wooden bulkhead installed in 1928, still in good condition after 46 years of service, just south of Boynton Inlet in Palm Beach

If properly designed and installed, timber can prove quite durable in a marine environment (Fig. 2). Timber piles over 1000 years old have been found in good condition under the streets of Venice, Italy.

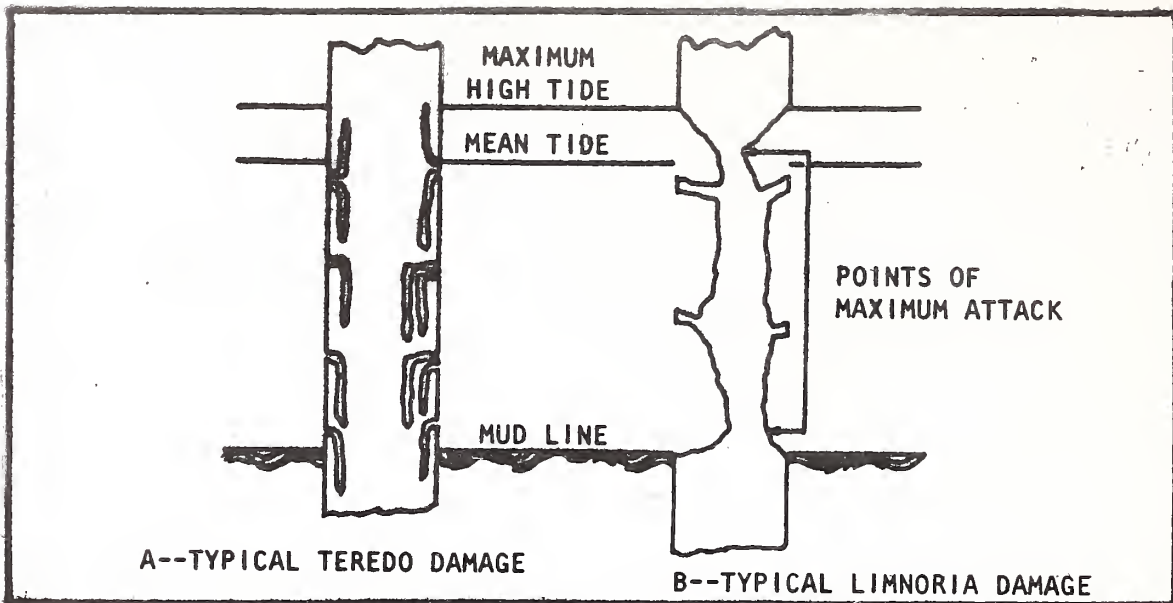
Fig. 3. Typical pile damage by marine borers

(iii) Marine borers consist of several hundred species of invertebrates divided into two groups, the Molluscan group and the Crustacean group (Figs. 3 and 4). The Molluscans, including the teredo or ship worm, enter the timber through minute holes and destroy the interior of the timber member without visible disturbance to the outer surface. The Crustaceans, including the limnoria, destroy the outside of the timber and leave easily seen gaps in the surface of the timber. Protection from the marine borers consists of impregnation with a creosote-coal tar solution and/or casing the timber between the mud line and the maximum high tide line with a protection coating of material impermeable to the borers (Ref. 7).

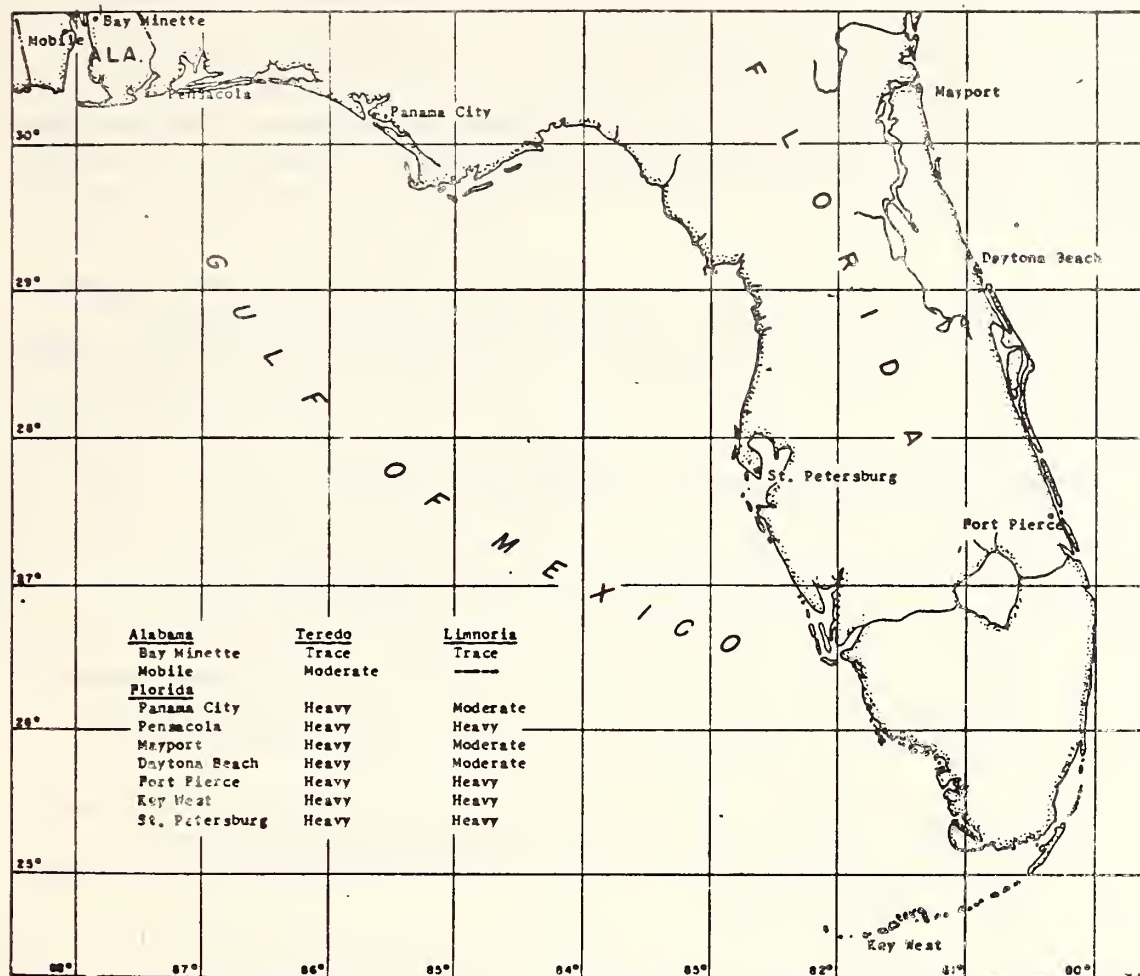
Fig. 4, Areas of infestation by marine borers in Florida

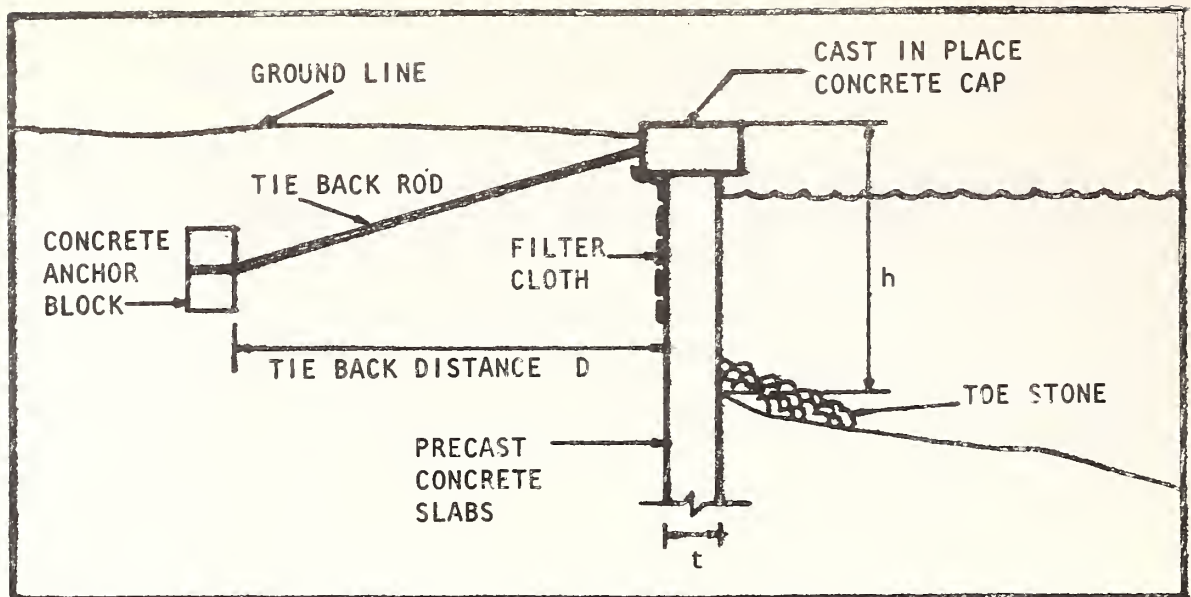
Hardened shore protection with a vertical seaward face may be installed in a relatively short time by using precast concrete slabs jettied into place or driven with a vibratory or impact hammer (Fig. 5). A concrete cap is usually cast on top of the slabs to serve both as a structural tie and to improve the finished appearance. Tie-backs are usually needed to prevent the wall from tipping seaward. Also, adequate penetration of the piles or slabs into the sea bottom is necessary to prevent the toe from sliding seaward. If wave action occurs against the vertical face, scour erosion at the toe of the wall may be expected. The wave energy breaking against the vertical face is deflected both upward and downward. The downward component of the deflected wave scours the sea bottom at the toe of the wall. Hardened toe protection may be required to prevent toe failure.

Fig. 5. Typical dimensions of precast concrete seawalls for protected waters

Both seawalls and bulkheads are referred to as seawalls in this publication to avoid the confusion of overlapping nomenclature. There are two basic types of seawalls. The most widely used consists of a vertical face of either precast concrete slabs (Fig. 5) or steel sheet piles (Figs. 6 & 7) driven into the sea bottom to secure the toe. The top is secured by anchor rods connecting the wall to anchors placed back a safe distance landward. The second type consists of massive free-standing gravity structures with curved, vertical or inclined faces designed to withstand the full force of the oncoming waves.

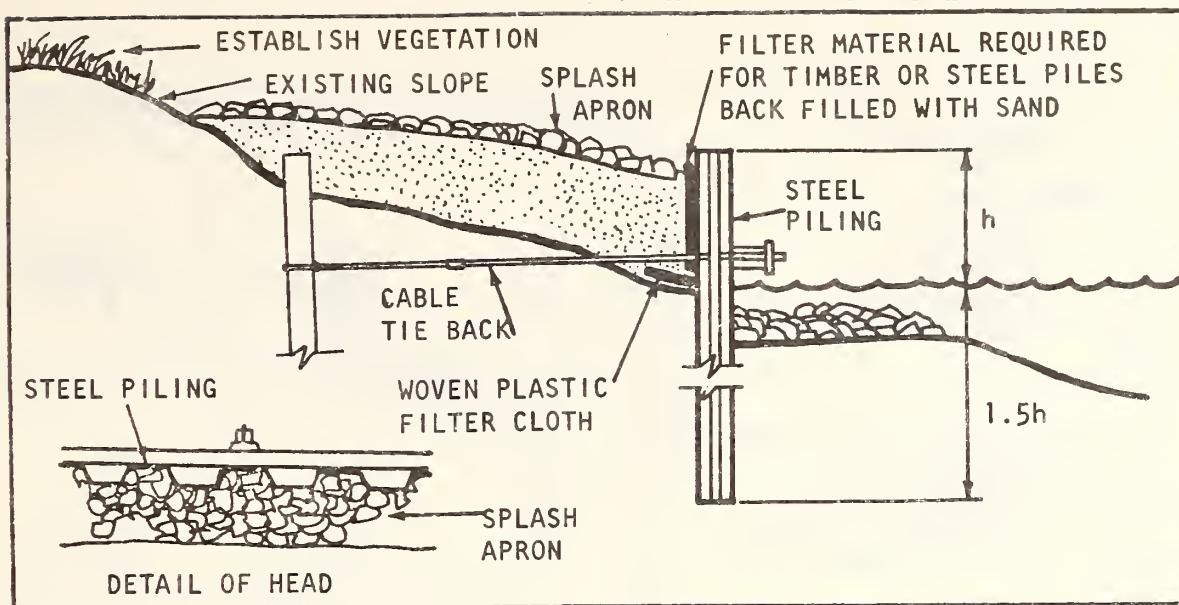
Fig. 6. Steel sheet pile seawall

A steel bulkhead serves to armor the bank. The face must be designed to absorb all wave energy. Severe scour occurs at the bulkhead line. The sheeting depends upon penetration and tie backs for its stability. The structural design of sheet piling is highly specialized and not subject to standard plans. For this reason the service of a qualified engineer is essential. Key design considerations are foundation conditions, penetration of the piling, height and alignment, and scour protection. Sufficient access must be available for pile driving equipment.

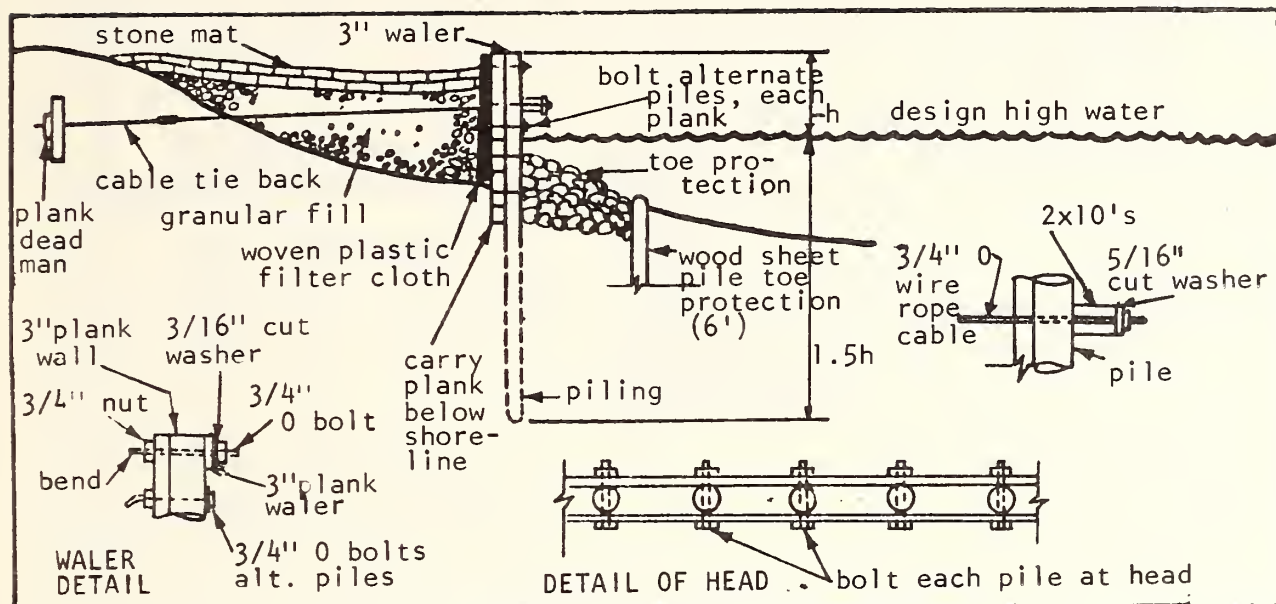
Fig. 7. Wood sheet pile seawall

Timber walls are constructed of plank sheeting with round piles. They consist of two rows of 3-inch plank sheeting and a row of round piling with heavy horizontal walls between the planks and the piling. They must be tied back to anchor piling. The most common cause of failure of sea walls is undermining of material from the bottom of the toe of the structure, resulting in inadequate penetration of piling. The pressure of the soil and water on the back side can then tip the structure. The tie-backs provide additional strength to resist this force. Timber bulkheads also require positive toe protection.

The piling and sheeting are driven with the aid of a jet from a small pump. The use of this design is controlled by subsurface foundation conditions. It is suitable for sand or sand and gravel shores where the sand deposit is 12-15 feet below the bottom. Wooden structures must be securely fastened together with bolts.

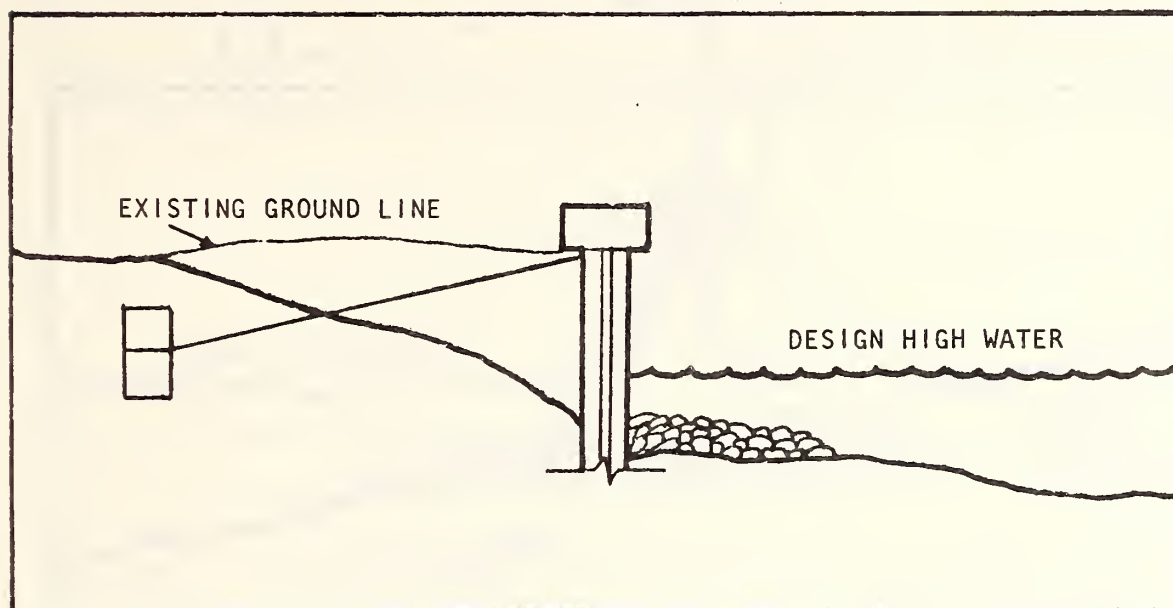
Fig. 8. Adequate toe penetration needed

Most failures of shore protection works results from "toe failure" or erosion under the lowest part of the structure. Failure of the bulkhead can be prevented with adequate toe protection. Toe protection must be substantial enough to prevent the original ground under it from washing through the toe protection blanket, and extend far enough seaward of the structure to prevent undermining. Check for signs of failure such as seaward movement of the wall, erosion behind or at the toe, or at the end of the structure.

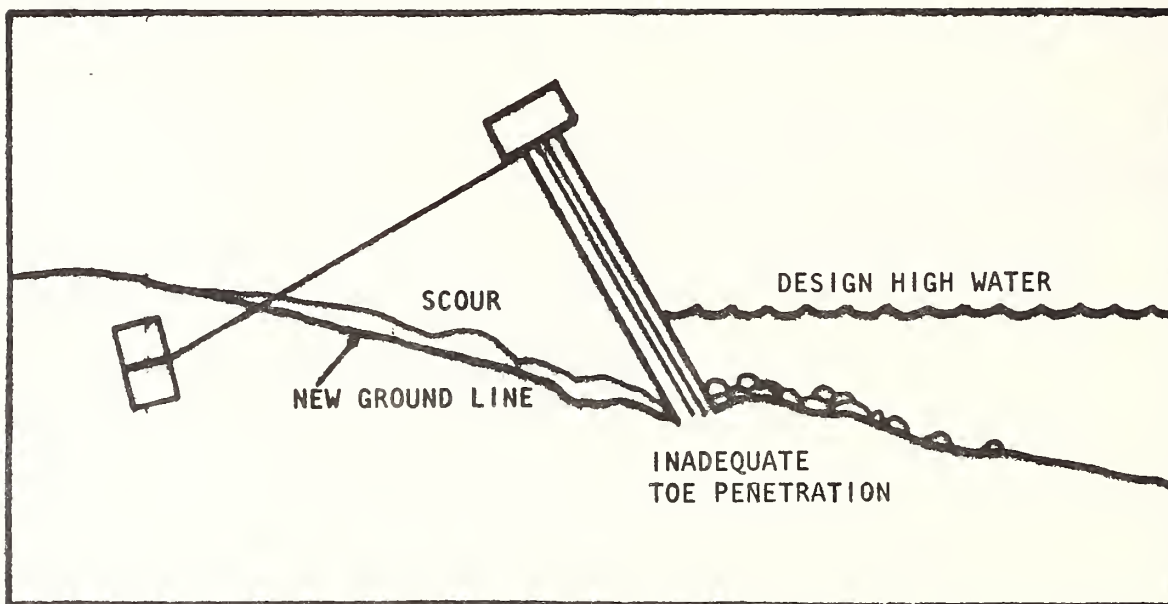
Fig. 9. Failure due to inadequate toe penetration

Re-establish support by underpinning, tie backs systems of anchor piling, walers and tie rods. Place larger stone or rock-filled mattress at toe of structure to prevent scour. Backfill where necessary.

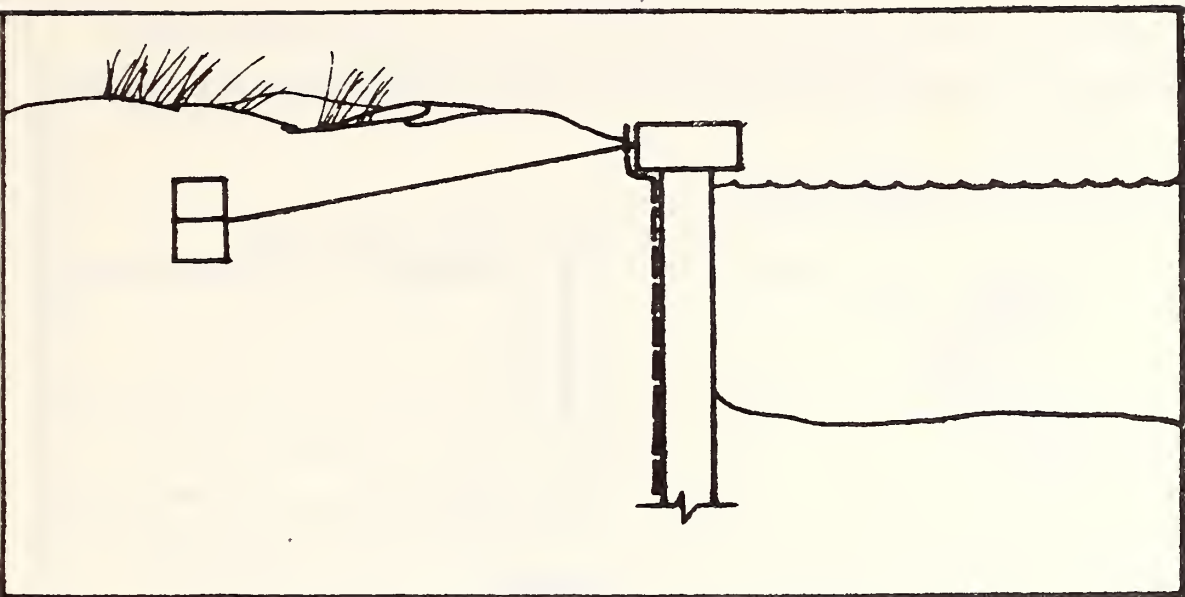
Fig. 10. Adequate anchorage needed

The pressure of the earth pushes the seawall seaward. Anchors that are too light or too close to the wall will pull out, permitting the wall to fall seaward. Tie-back rods that are too light or exposed to corrosion will break. Anchor design is an engineering specialty requiring an expert knowledge of soil mechanics. Check for signs of failure such as top of wall moving seaward, pockets or cracks forming in earth behind the seawall.

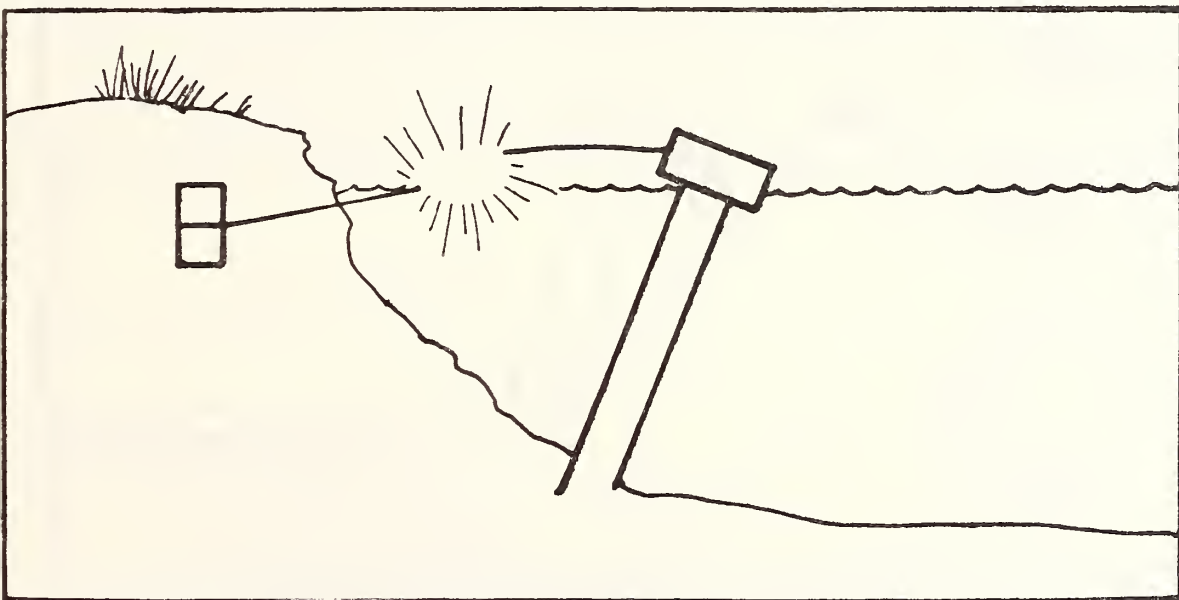
Fig. 11. Failure due to inadequate anchor tie-bar

Anchor blocks that are too light may be weighted by pouring more concrete on seaward side of anchor. Anchor blocks that are too close may be anchored back by placing a second large heavy anchor a safe distance landward and tying it to the existing system. If the tie-back rods are too small, add new tie rods, well wrapped and coated for protection against corrosion.

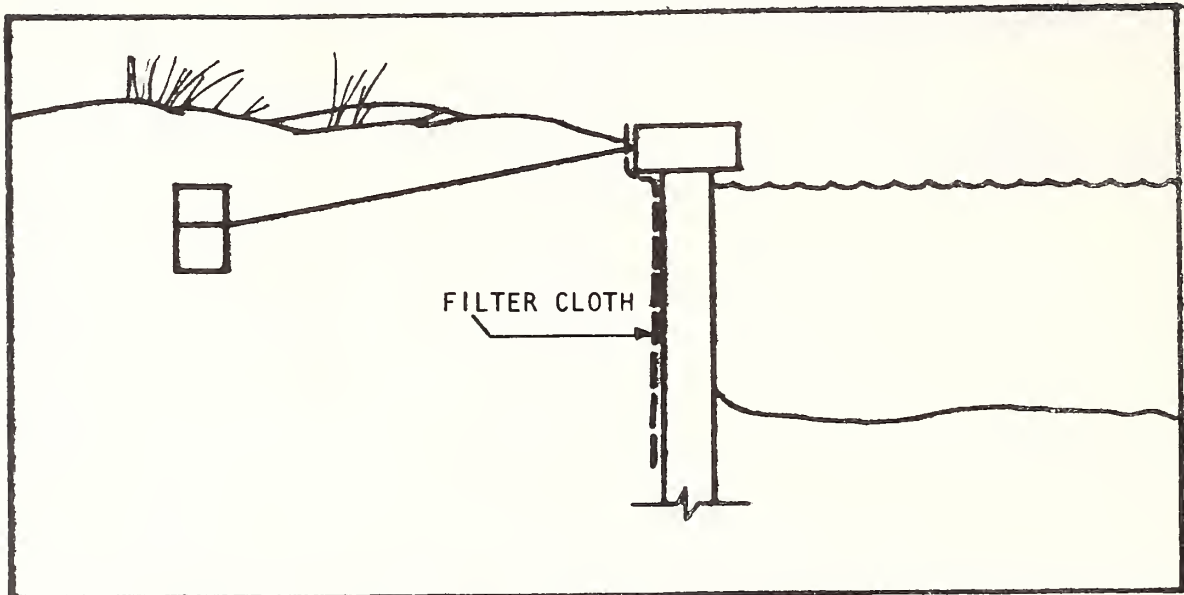
Fig. 12. Adequate earth support needed behind wall

The earth behind the wall provides support. If the supporting earth is washed out by storm water and/or other seepage, the wall collapses landward. Check for signs of failure such as pockets forming in the earth near joints.

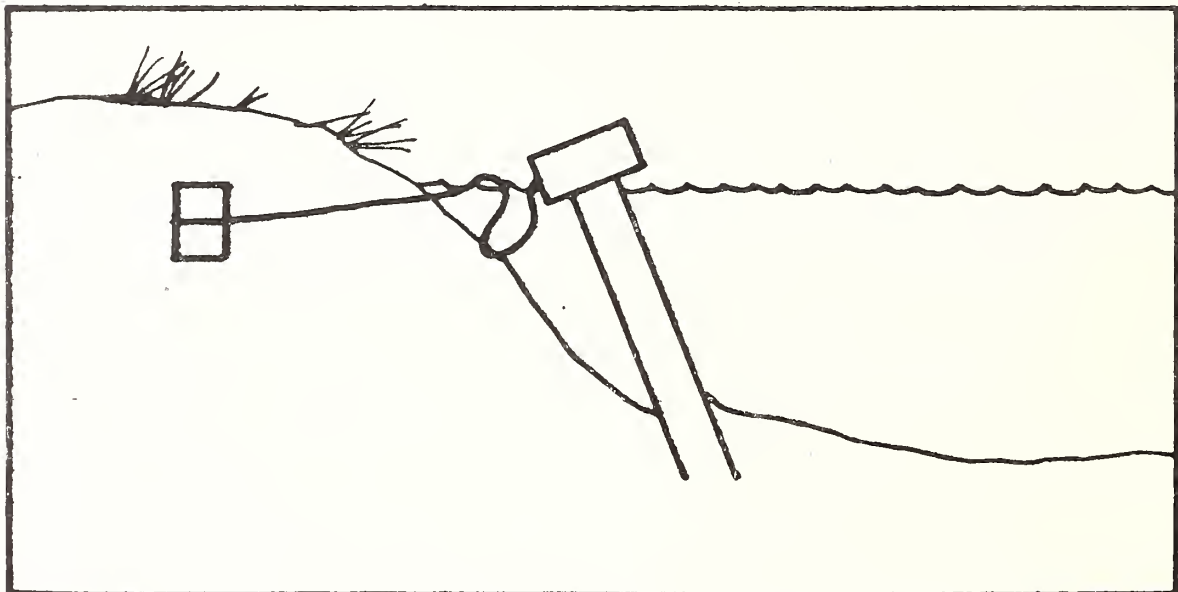
Fig. 13. Failure due to loss of earth support

Install filter cloth to intercept migrating soil. This permits water to pass and prevents buildup of water pressure, but retains the soil for support.

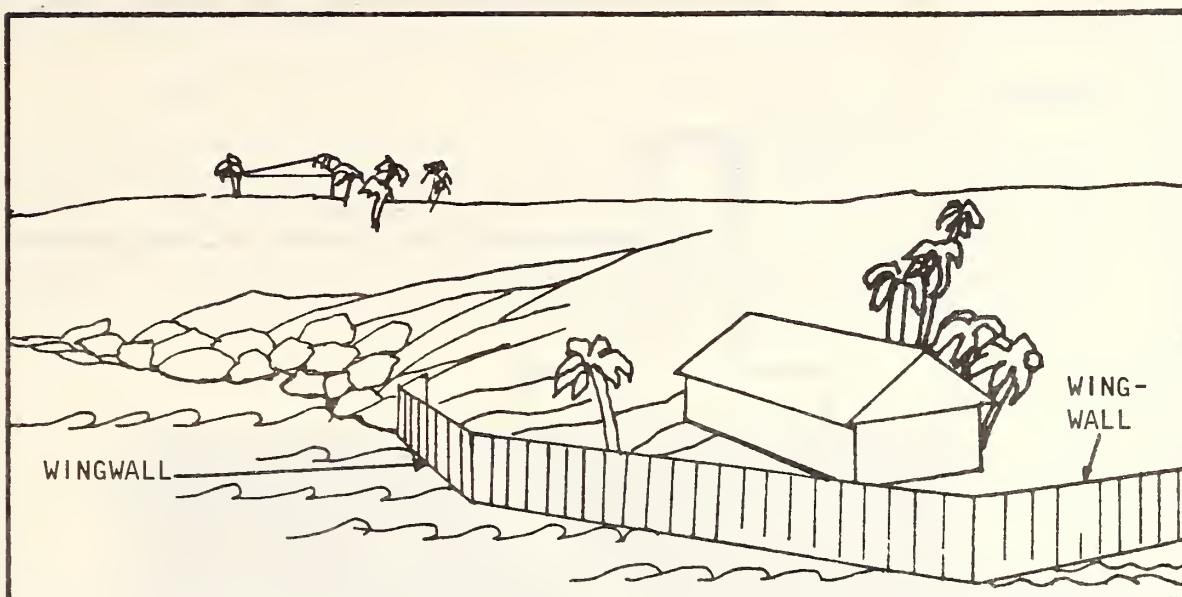
Fig. 14. Adequate end anchorage needed

Erosion will continue adjacent to the works. If an existing structure has been flanked, such as the one shown in Fig. 15, correct it by placing additional material at the ends and tying the works directly into the shore. Check for signs of failure such as seaward movement of the ends and erosion at the end of the structure. The illustration below shows the result of not constructing wingwalls and tying the ends of the structure into the shore.

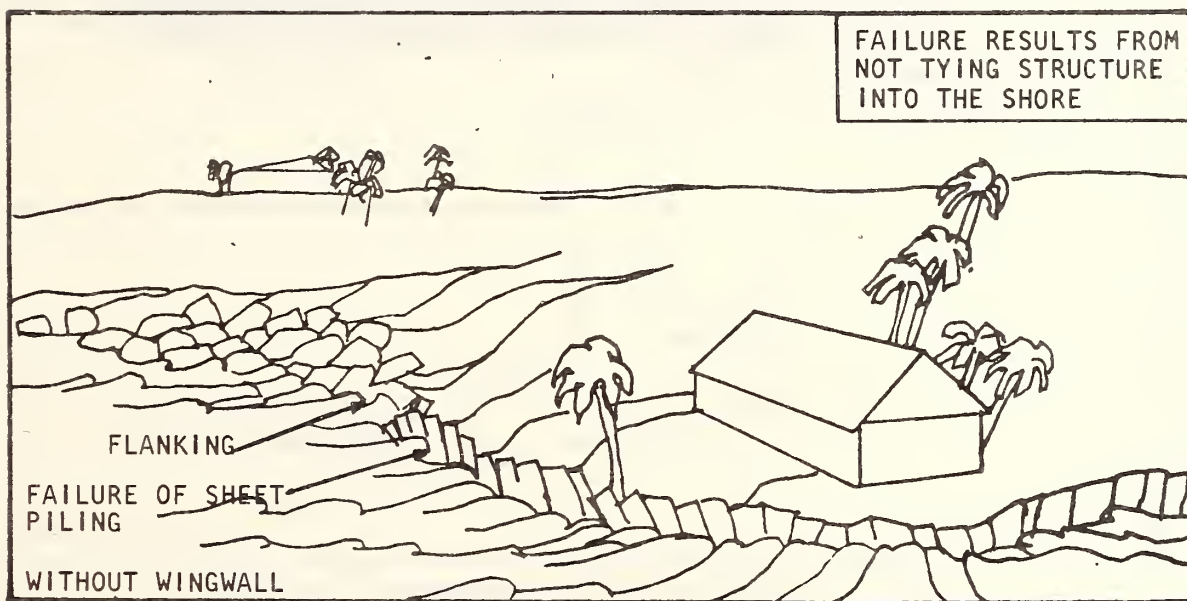
Fig. 15. Failure due to inadequate end anchorage

Place additional material at the ends and tie structure directly back into the shore. (Ref. 10)

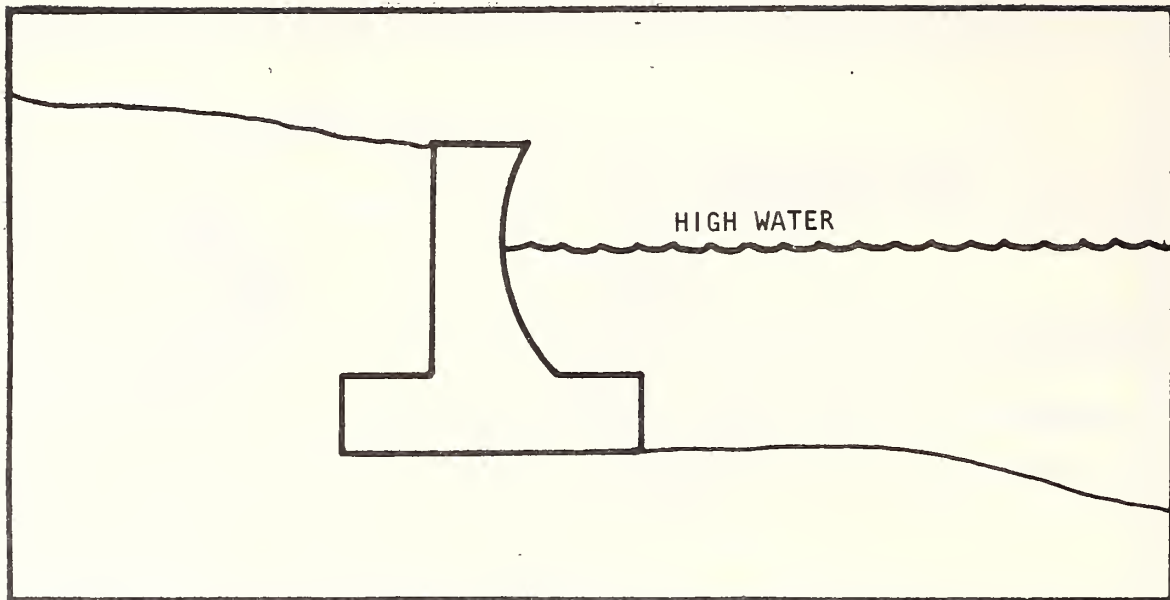
Fig. 16. Firm foundations are essential

Soft foundation material may result in excessive settlement of the structure. Soft underlayers may allow all or part of structure to slide. Check for settlement and excessive displacement. Hydrostatic pressure due to groundwater seepage may cause seaward movement of some types of impermeable walls.

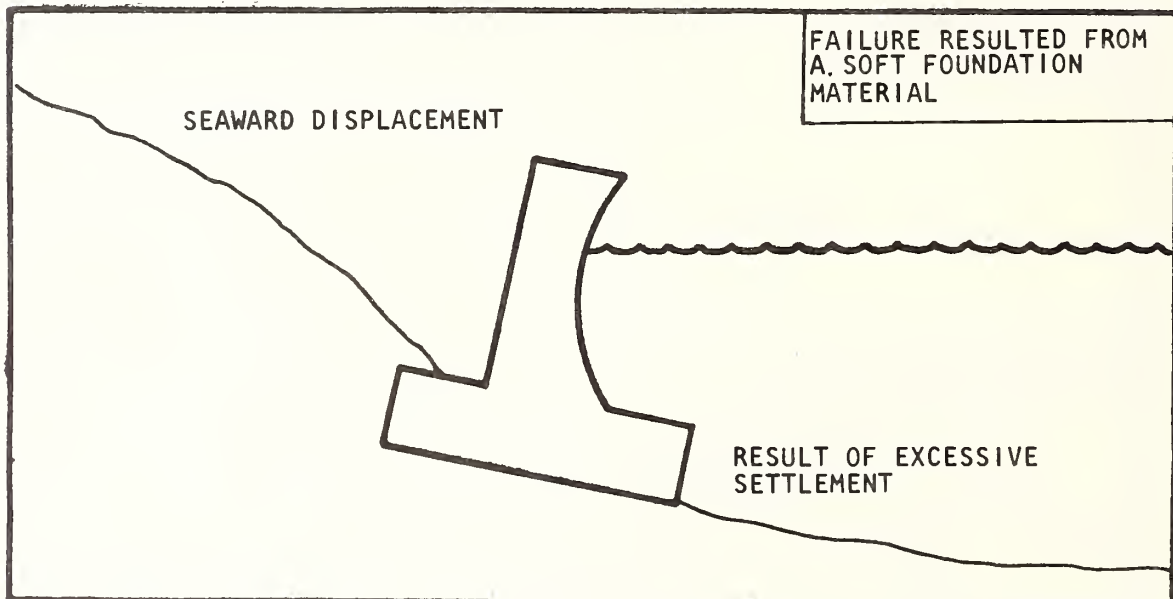
Fig. 17. Failure due to inadequate foundation

Re-establish support by construction underpinning, foundation protection and backfilling. If the structure was impermeable and failure was caused by foundation seepage, add or reopen weep holes. (Ref. 10)

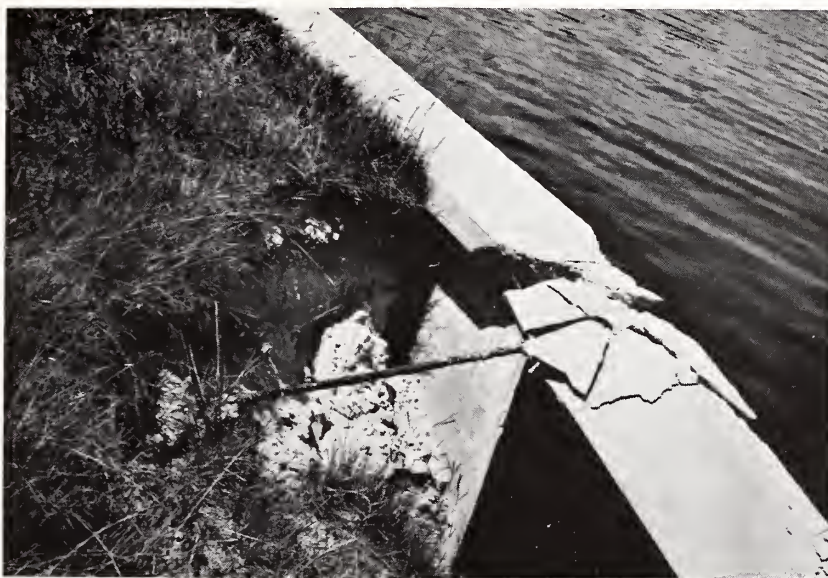
Fig. 18. Failure due to insufficient toe penetration

The anchor rods for this wall were adequate, but the toe of the wall had insufficient depth of penetration into the earth (Figs. 18 and 19). The pressure of the embankment caused the toe to swing seaward and the bank collapsed into the resulting cavity. Also shown is the formwork and reinforcing steel for replacement precast concrete slabs (Fig. 20). These will be jetted into place and a cap poured on top.

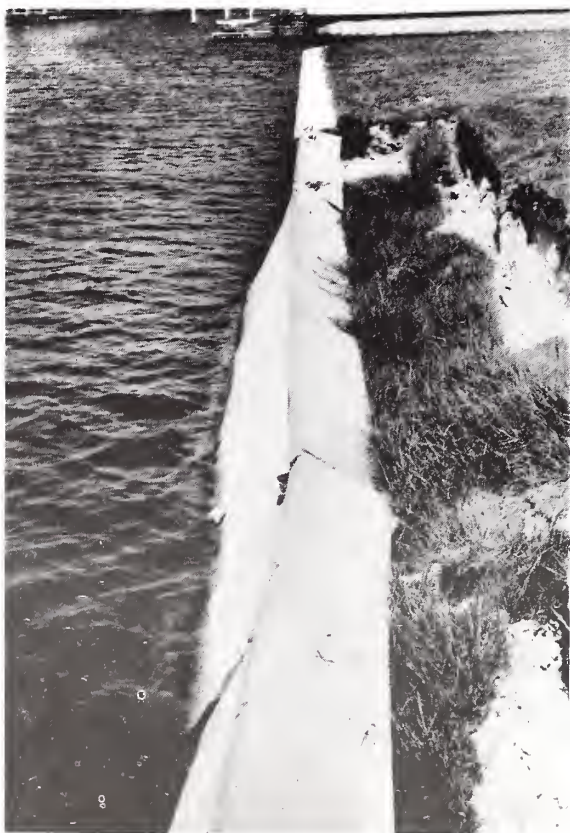
Fig. 19. Toe failure

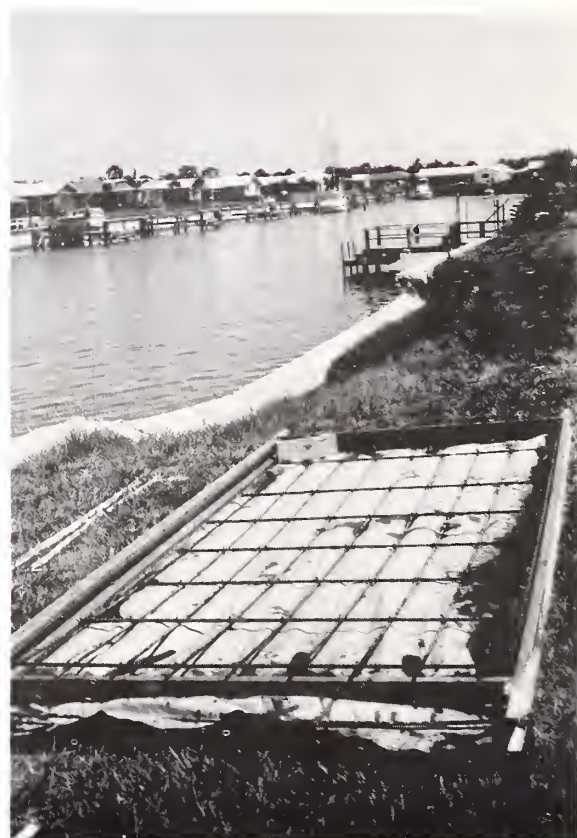
Fig. 20. Replacement slab

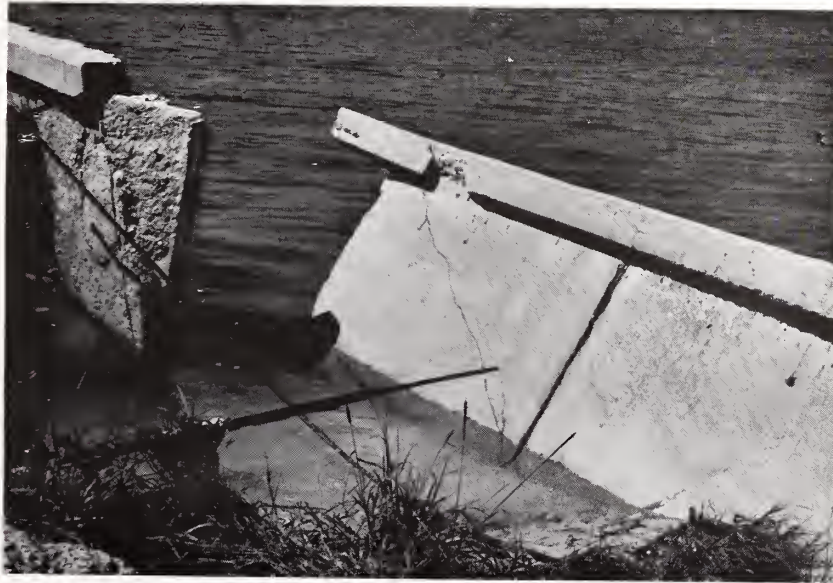
These tie-back rods (Fig. 21) were attacked by corrosion and eventually failed. This permitted the bank to push the top of the wall seaward, and the whole mass of earth and wall slid seaward. Rods should be of adequate size, thoroughly wrapped, coated or otherwise protected against corrosion, and firmly anchored to a well designed wall cap.

Fig. 21. Failure of anchor tie-back rod

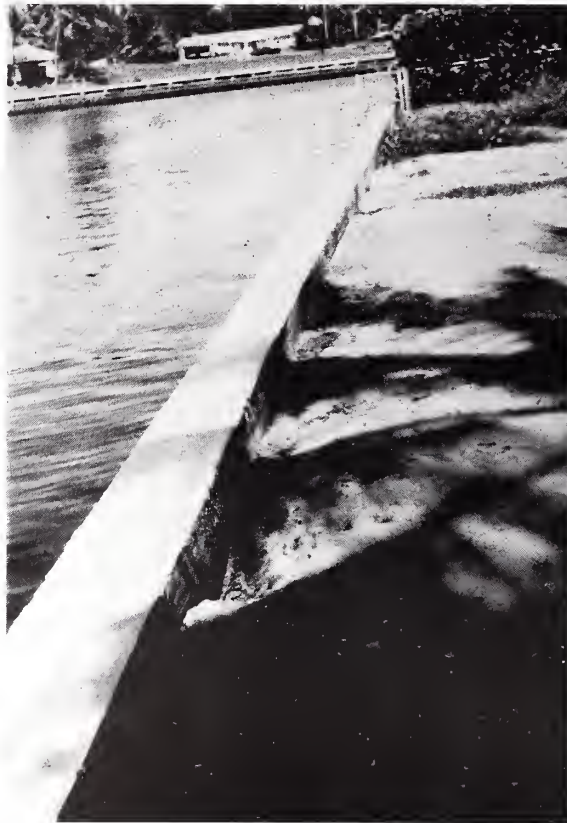
In Fig. 22, depressions are beginning to form in the earth behind the wall as rain and storm drainage washes the material through the joints of the wall or under the wall. If this loss continues, the wall may collapse landward due to complete loss of supporting backfill.

Fig. 22. First signs of loss of supporting backfill

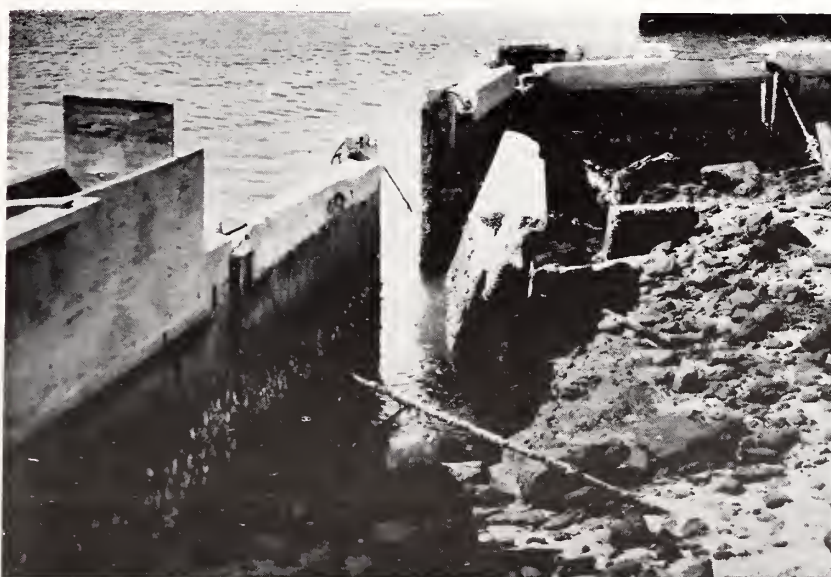
Fig. 23 below shows a similar seawall in a more advanced stage of failure due to loss of supporting backfill landward of the wall.

Fig. 23. Advanced stage of loss of supporting backfill

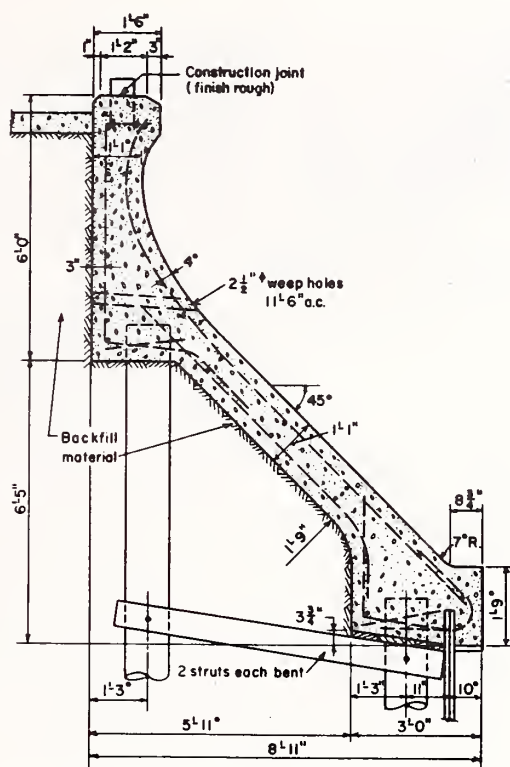
Fig. 24. Section of Bayshore
seawall, Tampa, Florida

with hurricane force from the south. Figs. 24 and 25 illustrate details of the design. In recent years there has been some minor spalling and some locations under the sidewalk have required mud jacking to compensate for minor amounts of fill washed out by stormwater filtration (Ref. 11).

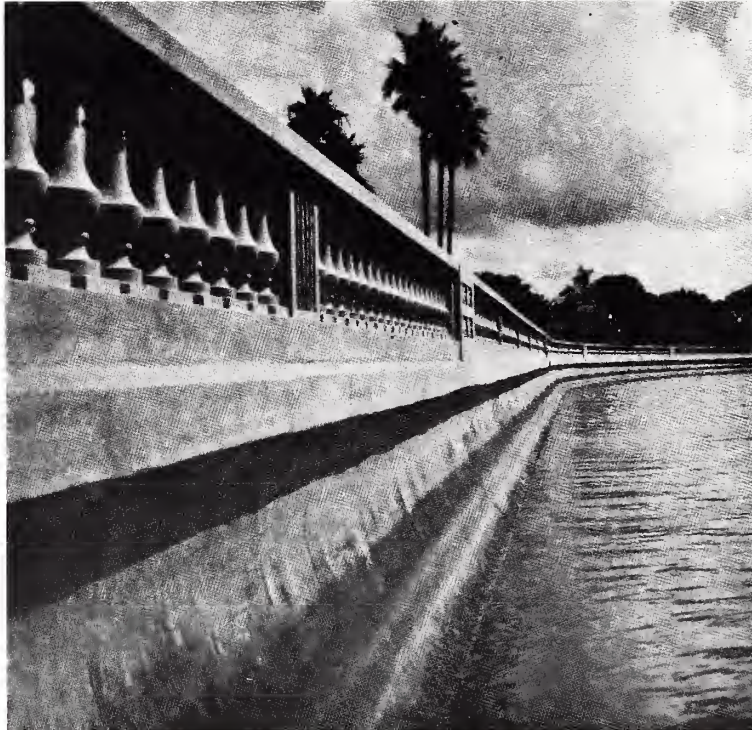
Fig. 25. View of Bayshore seawall,
Tampa, Florida, built in 1938

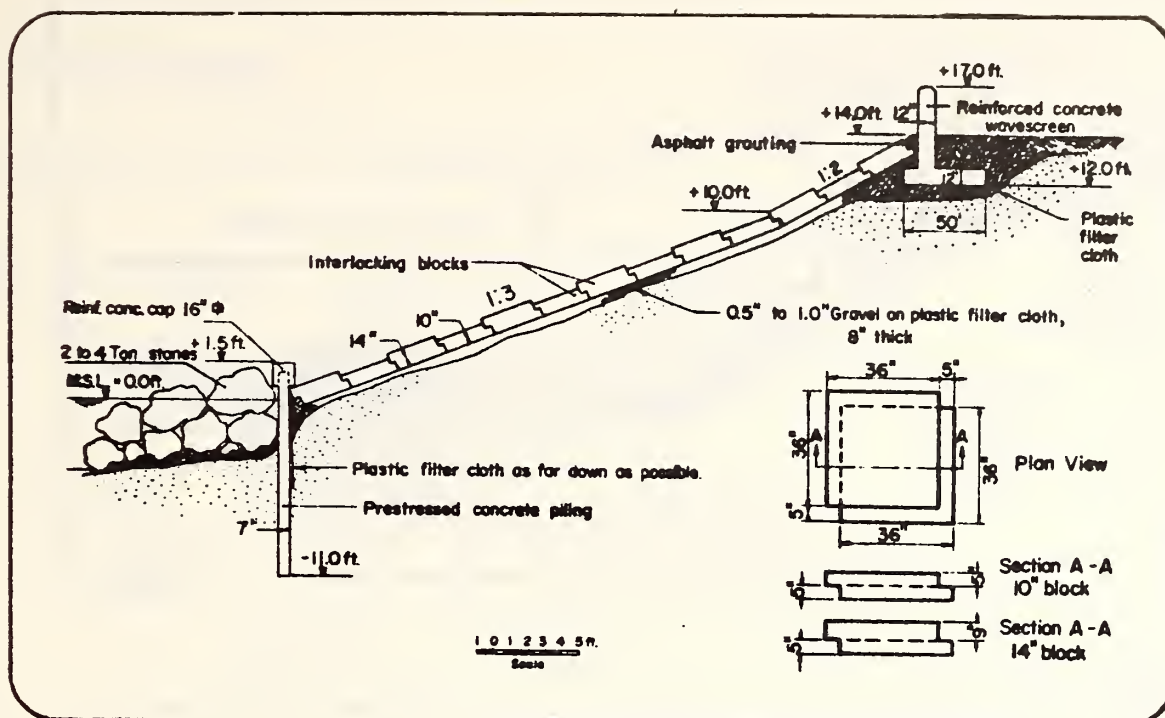
The precast concrete revetment is expensive but performs well when installed under favorable conditions (Fig. 26). A typical installation consists of 3' x 3' squares of interlocking concrete, alternating 10" and 14" in thickness. Under the block is a bedding layer of 3/4" stone about 10" to 12" thick underlain by a plastic filter sheet.

Fig. 26. Interlocking concrete-block revetment at Jupiter Island, Florida (Ref. 12)

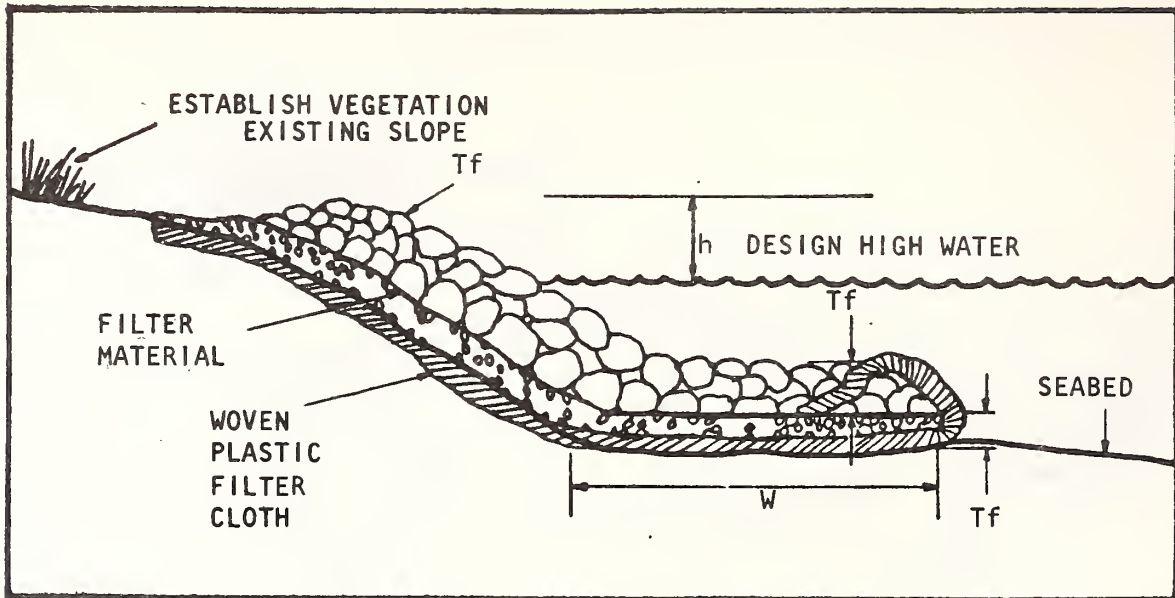
Fig. 27. Stone revetment (Ref. 10)

Stone revetment is the preferred method of shore protection. It is economical and suitable for all types of erosion problems when stone is available in sufficient size and quality. The key design considerations are the dimensions, foundation treatment, and stone size. Construction is not complicated and no special equipment, other than a crane and trucks, is needed.

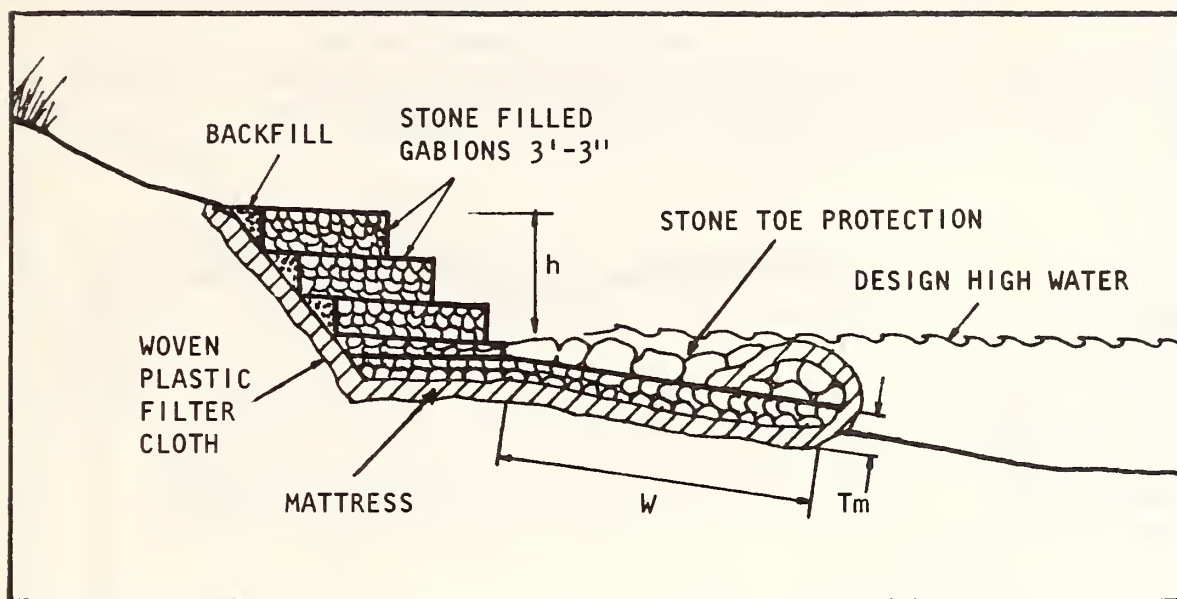
Fig. 28. Gabion revetment (Ref. 10)

A gabion is a steel wire mesh basket available commercially. Revetments can be constructed from stone filled gabions by groups of individuals without special construction equipment. Gabion structures can be built to any height required. A step design is suggested to reduce wave runup. The manufacturer's instructions should be followed closely. The structure should rest on an 18" thick gabion mattress to protect against scour. This type of construction is applicable to all shore-protection problems.

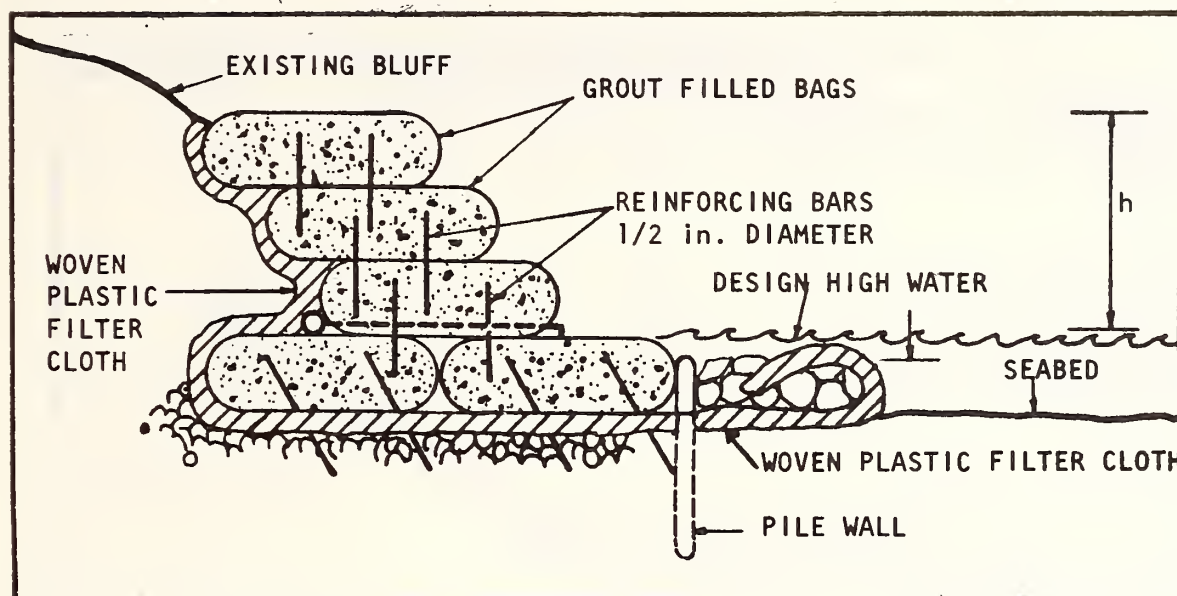
Fig. 29. Grout filled bag revetment (Ref. 10)

Large grout filled nylon bags (20' x 5' x 1.6") may be used to protect eroding shorelines. This type of structure is adaptable to all types of slopes. Bags should be placed parallel to the shore with reinforcing bars installed both vertically and horizontally as shown in the section below. This type of structure may be applicable where access is limited and rock is not readily available. No special material is needed other than the bags and construction is not complicated. A grout pump is required to fill the bags. Prices in the table below were computed with the assumption that ready-mix grout will be used, but a concrete mixer could be substituted at the site.

Remedial work on this type of structure is not easily accomplished. Special attention should be given to the protection. Uneven settlement or undermining might cause fracture or collapse. If excessive scour causes toe stone to settle, more material should be added. This type of structure is readily adaptable to add-on construction. Additional structure height can be easily accomplished if necessary. A lean mixture of sand cement consisting of as little as 3 bags of cement per cubic yard of mix is pumped into the bags with a portable concrete pump.

A typical bag when empty measures 5' by 10' and weighs about 5-1/2 pounds each. The bags may be filled in place on the beach by a 3" centrifugal bilge pump dredging 2-1/2 cubic
